Certified Inspection, Inc.
INSPECTION REPORT

8598 Holly Hill Dr
Tampa, FL

Prepared For
John Q. Smith

FILE #: Sample Report.
Address: 8598 Holly Hill Dr.
City, State: Tampa, FL.
Date: March 5, 2013.
Time: 2:00 PM.
Customer Name: John Q. Smith.
Inspector: Tom Bannister ASHI # 006204
State of Florida License HI 616

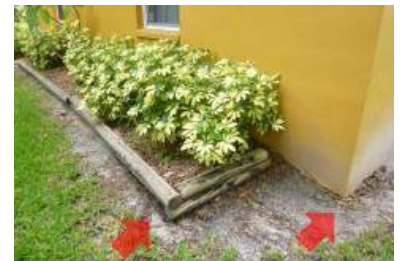
MAINTENANCE improvements could be done by a homeowner, call a landscaper if needed. There is erosion and at various places around the house, most notable around the air compressor and at the rear of the house. Provide fill dirt, sand, and/or rock as needed. Evaluate areas during rainy periods to determine remedial actions needed to prevent more erosion. Erosion is due to roof run off, common occurrence.

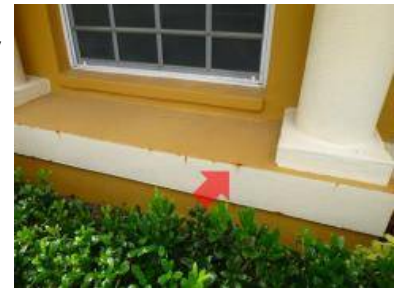
Maintenance Issues: MAINTENANCE Rust noted at the corners and edges around front windows, would indicate moisture is penetrating the stucco. It is highly recommended that the metal edging be sanded and painted to prevent further deterioration. If left unattended, the edging may need to be replaced with a plastic type of edging.

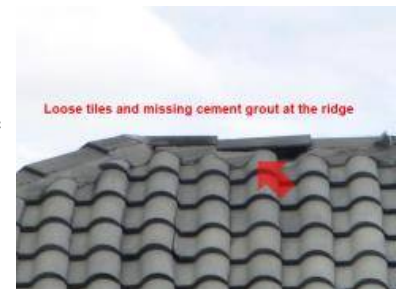
CEMENT/TILE ROOF: Life expectancy of a cement/tile roof is 15 - 25 years depending on the quality of the original installation and ongoing maintenance. The subsurface is designed to shed the water, while the tiles do shed water and protect the subsurface from deterioration due to the sun. Visual inspection of a tile roof is limited since much of the sub surface and components are concealed. Cracked and loose tiles are fairly common occurrences, therefore the tiles roofs will need periodic maintenance. It is considered normal maintenance to replace damaged tiles, caulk cracked tiles, and secure loose tiles. As the roof ages it is sometimes beneficial to clean and paint the roof.

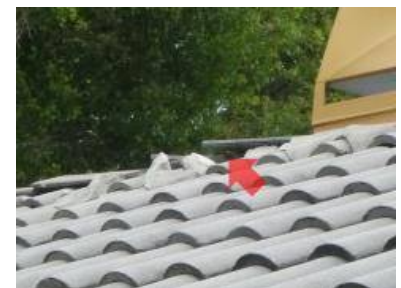
The roof was inspected by placing a ladder at the eaves. Due to the potential of damaging tiles, the inspector will not walk on a tile roof.

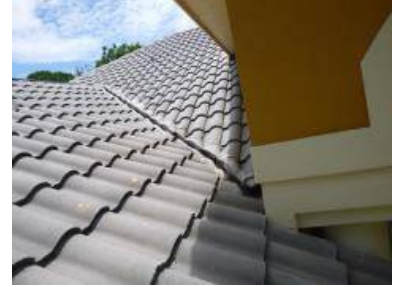
Observations: There is a section of the roof that is directed toward a side wall of the home above the front porch. Obviously if the roof is directing water toward a wall, there is a potential of leakage into the wall. The area should be monitored on a periodic basis and maintained as needed, i.e. flashing sealed, debris not allowed to gather, cracks in the wall sealed, etc.

Active Leak: CORRECTIVE call a roofing contractor to evaluate and take remedial action as needed. Evidence of leakage noted at the garage ceiling directly below the wall flashing at the east side of the front porch. A moisture detector was used and an elevated moisture reading was observed. see above photo.

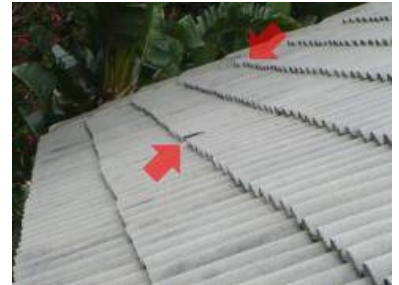
Tile Roof Issues: CORRECTIVE call a roofing contractor to evaluate and make remedial repairs as needed. Cracked and loose tiles noted in multiple places, most notable at the ridge caps. Mortar is loose at the ridge caps resulting in the loose tiles. More than 6 dozen cracked and loose tiles noted, repairs recommended to prevent damage to the sub surfaces due to ultraviolet sun rays.

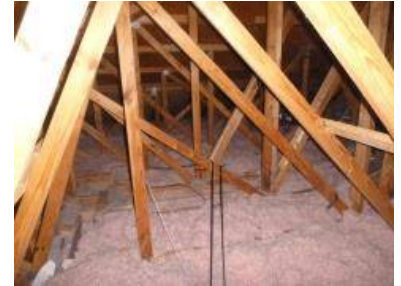
Inspection Method: Attic access located in the garage. The inspector did enter the attic, inspection of extreme areas is limited. The design of the roof/attic structure limits safe passage through the attic. The addition of bracing and/or decking may allow for safe passage to remote areas. Passage through the attic and visibility of components is restricted due to the HVAC ducts and insulation.

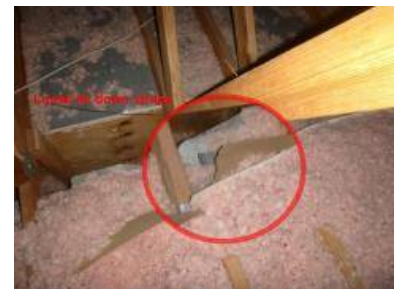
Tie Downs: Random evaluation revealed the type and installation of visible structural components through out the attic are common to homes of this age and type of construction. Building standards are constantly being evaluated and changed to improve performance. Obviously the newer the home, the more consistent it will be with current standards. Tie down clips are used to secure the framing to the side walls in some places. Tie down straps are used to secure the framing to the side wall in most places. Some installation issues were noted. Fewer nails used to secure the straps than currently recommended. There are standards that recommend a minimum of 2 nails on the front side and a minimum of 1 nail on the opposite side. Loose straps noted. The issues noted can compromise the structural integrity but may only be an issue during a catastrophic event. For any further evaluation and possible remedies consult with a general contractor and/or an engineer.

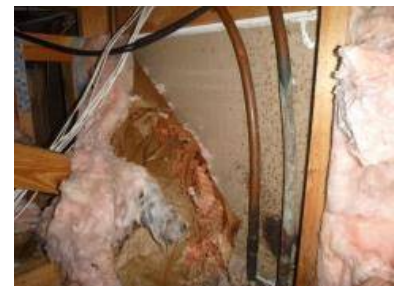
Insulation issues: MAINTENANCE . The insulation has pulled loose in areas, will allow for excess heat into living areas. Recommend the insulation be secured as intended. Common maintenance issue, contact a contractor to repair if beyond your abilities.

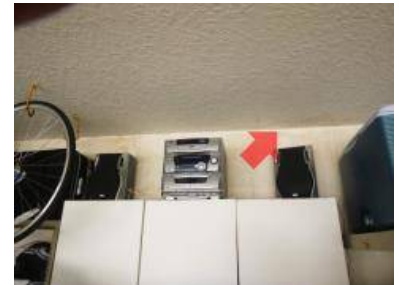
Ceilings: CORRECTIVE Ceiling issues were noted. Staining and deterioration noted at the garage ceiling nearest the front porch, Area was check with a moisture meter and an elevated moisture content was noted. Stains likely due to leakage from the roof were it is directed toward the front porch. Make cosmetic improvements after the roof is repaired. see roof section of this report.

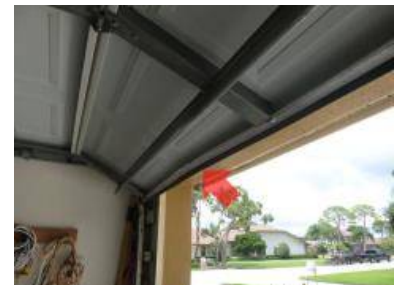
Door issues: MAINTENANCE Damaged noted to the bottom panel of the garage door, door is worn and weakened due to age and use. Additional bracing could be added to strengthen the bottom panel of door. Due to the condition of the panel, panel/door replacement should be considered. Obviously damaged panels could weaken the door, may only be an issue in a catastrophic event.

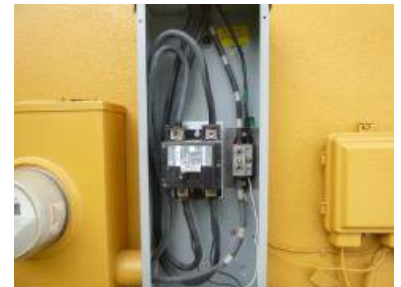
Evaluation: The interior components of the Main Service Panel (load center) were inspected by removing the dead front cover. No interior components in the panel were removed. SERVICEABLE The size of the breakers in relation to the attached cable (conductors) appears to meet standards.

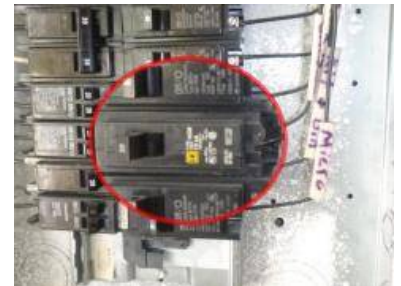
Over fusing: CORRECTIVE contact an electrician to evaluate and make remedial repairs as needed. Over fusing noted at a 30 amp breaker. Over fusing occurs when the wire (conductor) for a breaker and/or a fuse is too small in relation to the size of the breaker/fuse used to protect the wire. The breaker/fuse will allow more power through the wire than the wire is capable of safely conducting. This could result in the wires over heating.

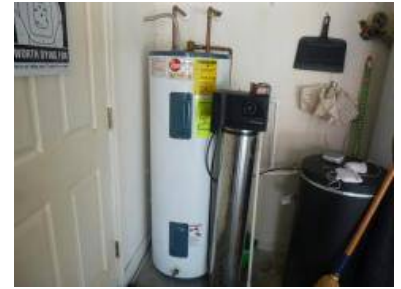
Observations: FURTHER EVALUATION When operating water faucets throughout the home, dirty water was noted, most probably due to the condition of the interior of the water heater. Condition may improve by flushing the system. If flushing the system does not improve the quality of water, contact a plumber, water heater replacement maybe needed.

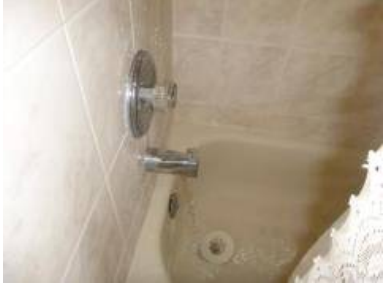
- Tub Issues:* CORRECTIVE call a plumber for repair as needed. Tub faucet is leaking at stem when operated, may allow for drainage back into the wall. Packing glands will need repaired and/or the faucet replaced.

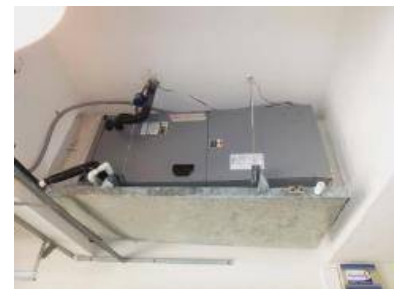
Air Handler issues: The air handler is located in the garage. Air handlers located in a garage will tend to have more moisture issues due to the cooling that occurs in an air handler and being located in a hot garage. Seals for the air handler and the ducts need to be well maintained to prevent moist exterior air and car fumes from entering the home. Monitor and maintain as needed. Dirt on the air handler coils will lessen the efficiency of the system, recommend the coils be cleaned on a periodic basis to maintain system operation.

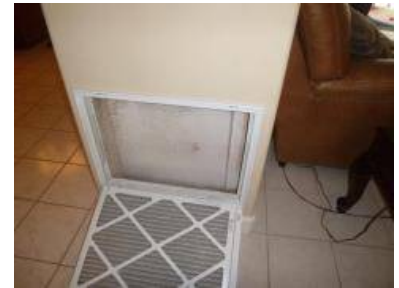
INDETERMINATE The duct system is installed in a manor that uses wall cavities for the air returns. There are building standards that recommend the use of approved sealed ducts versus wall cavities in order to provide a closed air conditioning system. Using wall cavities for ducts will allow for air to bypass filters and pull air from unconditioned areas resulting in lower system efficiency. Consideration should be given to upgrading to a fully enclosed duct system.

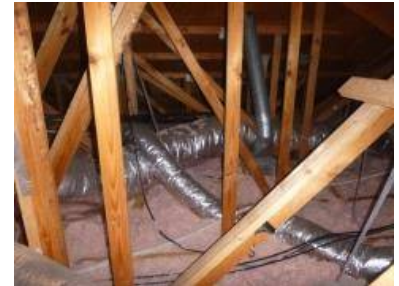
INDETERMINATE HVAC installation standards are constantly being evaluated and changed to improve performance. The following information is intended to identify duct installation issues that don't conform to current building standards. Improvements/modifications are at homeowner discretion but should be considered to improve duct performance. It maybe beneficial to have an energy audit by the local utility provider. Contact a HVAC contractor for any further evaluation. Duct connections at distribution boxes are not sealed with a mastic, will be more prone to leakage. Use a mastic to seal all connections to reduce system leakage. Common standards allow for a 1/2 inch drop per foot of duct, more slope/drop in a duct may reduce the air flow through the duct. There are ducts that slope more than recommended. Efficiency of the system could be improved by adjusting the slope of the ducts. The ducts are not supported and/or are laying on top of the insulation. Ducts in direct contact with insulation are more vulnerable to condensation issues. Ducts should be supported according to the manufacturer's instructions.
