Certified Inspection, Inc.
INSPECTION REPORT

8598 Holly Hill Dr
Tampa, FL

Prepared For
John Q. Smith

FILE #: Sample Report.
Address: 8598 Holly Hill Dr.
City, State: Tampa, FL.
Date: March 5, 2013.
Time: 2:00 PM.
Customer Name: John Q. Smith.
Inspector: Tom Bannister ASHI # 006204
State of Florida License HI 616

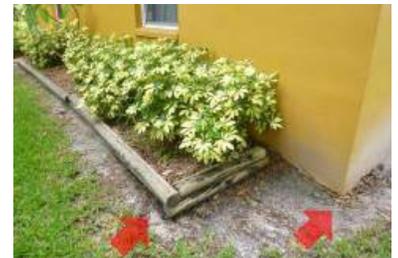
MAINTENANCE improvements could be done by a homeowner, call a landscaper if needed. There is erosion and at various places around the house, most notable around the air compressor and at the rear of the house. Provide fill dirt, sand, and/or rock as needed. Evaluate areas during rainy periods to determine remedial actions needed to prevent more erosion. Erosion is due to roof run off, common occurrence.

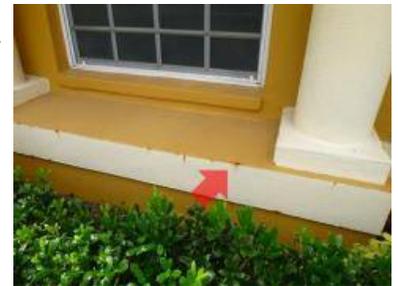
Maintenance Issues: MAINTENANCE Rust noted at the corners and edges around front windows, would indicate moisture is penetrating the stucco. It is highly recommended that the metal edging be sanded and painted to prevent further deterioration. If left unattended, the edging may need to be replaced with a plastic type of edging.

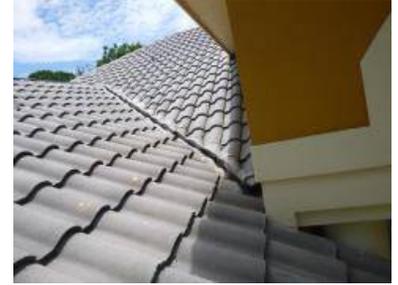
Observations: There is a section of the roof that is directed toward a side wall of the home above the front porch. Obviously if the roof is directing water toward a wall, there is a potential of leakage into the wall. The area should be monitored on a periodic basis and maintained as needed, i.e. flashing sealed, debris not allowed to gather, cracks in the wall sealed, etc.

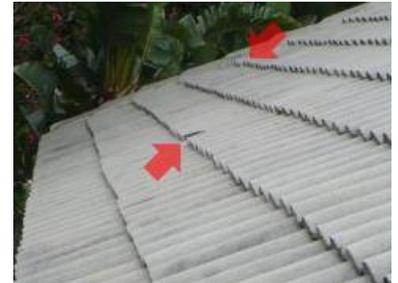
Tile Roof Issues: CORRECTIVE call a roofing contractor to evaluate and make remedial repairs as needed. Cracked and loose tiles noted in multiple places, most notable at the ridge caps. Mortar is loose at the ridge caps resulting in the loose tiles. More than 6 dozen cracked and loose tiles noted, repairs recommended to prevent damage to the sub surfaces due to ultraviolet sun rays.

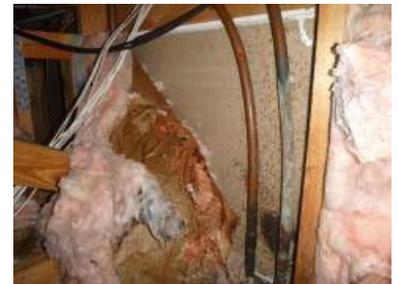
Insulation issues: MAINTENANCE . The insulation has pulled loose in areas, will allow for excess heat into living areas. Recommend the insulation be secured as intended. Common maintenance issue, contact a contractor to repair if beyond your abilities.

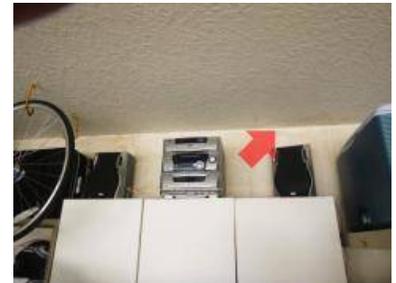
Active Leak: CORRECTIVE call a roofing contractor to evaluate and take remedial action as needed. Evidence of leakage noted at the garage ceiling directly below the wall flashing at the east side of the front porch. A moisture detector was used and an elevated moisture reading was observed. see above photo.

Ceilings: CORRECTIVE Ceiling issues were noted. Staining and deterioration noted at the garage ceiling nearest the front porch, Area was check with a moisture meter and an elevated moisture content was noted. Stains likely due to leakage from the roof were it is directed toward the front porch. Make cosmetic improvements after the roof is repaired. see roof section of this report.

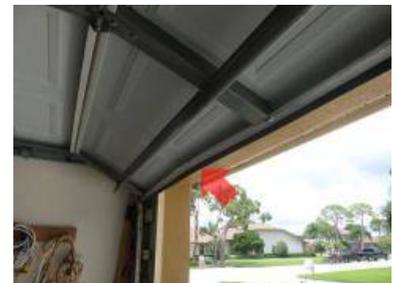
Door issues: MAINTENANCE Damaged noted to the bottom panel of the garage door, door is worn and weakened due to age and use. Additional bracing could be added to strengthen the bottom panel of door. Due to the condition of the panel, panel/door replacement should be considered. Obviously damaged panels could weaken the door, may only be an issue in a catastrophic event.

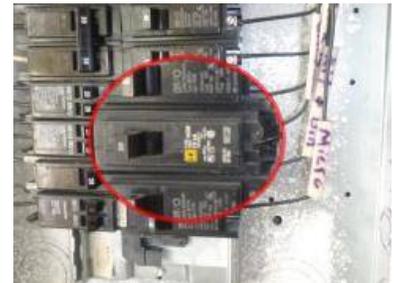
Over fusing: CORRECTIVE contact an electrician to evaluate and make remedial repairs as needed. Over fusing noted at a 30 amp breaker. Over fusing occurs when the wire (conductor) for a breaker and/or a fuse is too small in relation to the size of the breaker/fuse used to protect the wire. The breaker/fuse will allow more power through the wire than the wire is capable of safely conducting. This could result in the wires over heating.

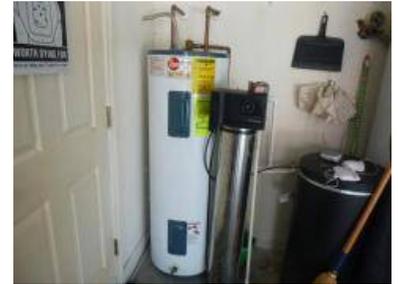
Observations: FURTHER EVALUATION When operating water faucets throughout the home, dirty water was noted, most probably due to the condition of the interior of the water heater. Condition may improve by flushing the system. If flushing the system does not improve the quality of water, contact a plumber, water heater replacement maybe needed.

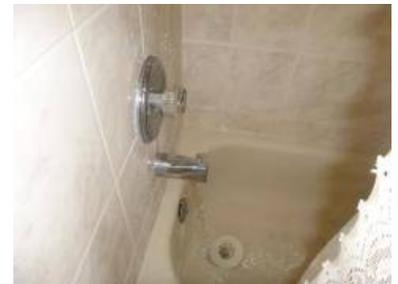
- Tub Issues:* CORRECTIVE call a plumber for repair as needed. Tub faucet is leaking at stem when operated, may allow for drainage back into the wall. Packing glands will need repaired and/or the faucet replaced.

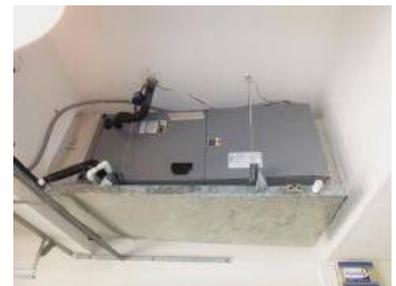
Air Handler issues: The air handler is located in the garage. Air handlers located in a garage will tend to have more moisture issues due to the cooling that occurs in an air handler and being located in a hot garage. Seals for the air handler and the ducts need to be well maintained to prevent moist exterior air and car fumes from entering the home. Monitor and maintain as needed. Dirt on the air handler coils will lessen the efficiency of the system, recommend the coils be cleaned on a periodic basis to maintain system operation.

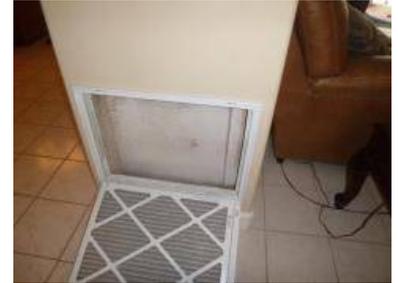
INDETERMINATE The duct system is installed in a manor that uses wall cavities for the air returns. There are building standards that recommend the use of approved sealed ducts versus wall cavities in order to provide a closed air conditioning system. Using wall cavities for ducts will allow for air to bypass filters and pull air from unconditioned areas resulting in lower system efficiency. Consideration should be given to upgrading to a fully enclosed duct system.

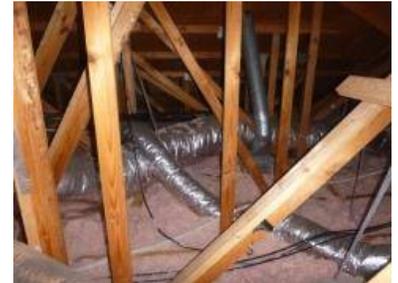
INDETERMINATE HVAC installation standards are constantly being evaluated and changed to improve performance. The following information is intended to identify duct installation issues that don't conform to current building standards. Improvements/modifications are at homeowner discretion but should be considered to improve duct performance. It maybe beneficial to have an energy audit by the local utility provider. Contact a HVAC contractor for any further evaluation. Duct connections at distribution boxes are not sealed with a mastic, will be more prone to leakage. Use a mastic to seal all connections to reduce system leakage. Common standards allow for a 1/2 inch drop per foot of duct, more slope/drop in a duct may reduce the air flow through the duct. There are ducts that slope more than recommended. Efficiency of the system could be improved by adjusting the slope of the ducts. The ducts are not supported and/or are laying on top of the insulation. Ducts in direct contact with insulation are more vulnerable to condensation issues. Ducts should be supported according to the manufacturer's instructions.
