Certified Inspection, Inc.
INSPECTION REPORT

8598 Holly Hill Dr
Tampa, FL

Prepared For
John Q. Smith

FILE #: Sample Report.
Address: 8598 Holly Hill Dr.
City, State: Tampa, FL.
Date: March 5, 2013.
Time: 2:00 PM.
Customer Name: John Q. Smith.
Inspector: Tom Bannister ASHI # 006204
State of Florida License HI 616

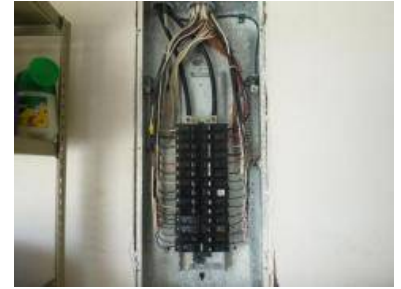
Primary Sub Panel Amperage: Primary sub panel is rated for 200 AMPS.

Main Breaker: No main breaker in the primary sub panel, common for this type of installation. Main breaker would be at the main panel.
