Certified Inspection, Inc.
INSPECTION REPORT

8598 Holly Hill Dr
Tampa, FL

Prepared For
John Q. Smith

FILE #: Sample Report.
Address: 8598 Holly Hill Dr.
City, State: Tampa, FL.
Date: March 5, 2013.
Time: 2:00 PM.
Customer Name: John Q. Smith.
Inspector: Tom Bannister ASHI # 006204
State of Florida License HI 616

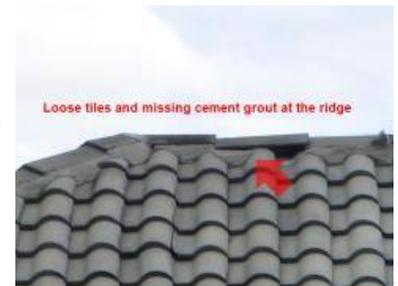
CEMENT/TILE ROOF: Life expectancy of a cement/tile roof is 15 - 25 years depending on the quality of the original installation and ongoing maintenance. The subsurface is designed to shed the water, while the tiles do shed water and protect the subsurface from deterioration due to the sun. Visual inspection of a tile roof is limited since much of the sub surface and components are concealed. Cracked and loose tiles are fairly common occurrences, therefore the tiles roofs will need periodic maintenance. It is considered normal maintenance to replace damaged tiles, caulk cracked tiles, and secure loose tiles. As the roof ages it is sometimes beneficial to clean and paint the roof.

Roof is the same age as the home.

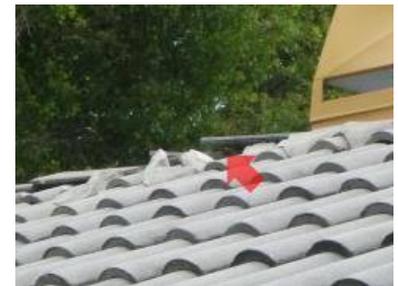
The roof was inspected by placing a ladder at the eaves. Due to the potential of damaging tiles, the inspector will not walk on a tile roof.

- As tile roofs age, they will normally exhibit cracked and loose tile, gaps at mortar joints, and rust at flashing. Tile roofs will benefit with periodic maintenance as needed. Loose tiles should be secured, cracked tiles should be sealed, and the roof cleaned as needed. Rusted flashings should be sanded and painted. Monitor and maintain as needed.

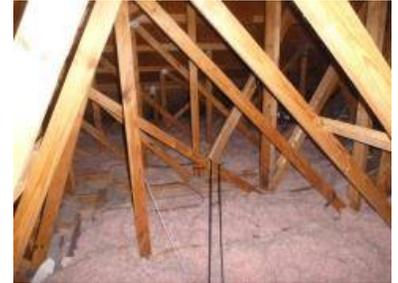
Inspection Method: Attic access located in the garage. The inspector did enter the attic, inspection of extreme areas is limited. The design of the roof/attic structure limits safe passage through the attic. The addition of bracing and/or decking may allow for safe passage to remote areas. Passage through the attic and visibility of components is restricted due to the HVAC ducts and insulation.

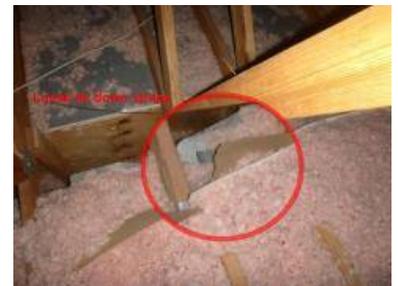
Tie Downs: Random evaluation revealed the type and installation of visible structural components through out the attic are common to homes of this age and type of construction. Building standards are constantly being evaluated and changed to improve performance. Obviously the newer the home, the more consistent it will be with current standards. Tie down clips are used to secure the framing to the side walls in some places. Tie down straps are used to secure the framing to the side wall in most places. Some installation issues were noted. Fewer nails used to secure the straps than currently recommended. There are standards that recommend a minimum of 2 nails on the front side and a minimum of 1 nail on the opposite side. Loose straps noted. The issues noted can compromise the structural integrity but may only be an issue during a catastrophic event. For any further evaluation and possible remedies consult with a general contractor and/or an engineer.

Insulation: Insulation is located in the attic flooring and vaulted ceiling side walls. Combination of Fiberglass batts and Fiberglass Blown-in, 7 to 10 inches of insulation noted in most areas. Some insulation is installed unevenly, consideration should be given to distributing the insulation evenly. Consideration should be given to getting an energy audit by the local power company for any energy programs that may be available and to learn about ways to improve energy efficiency.

Insulation issues: MAINTENANCE . The insulation has pulled loose in areas, will allow for excess heat into living areas. Recommend the insulation be secured as intended. Common maintenance issue, contact a contractor to repair if beyond your abilities.

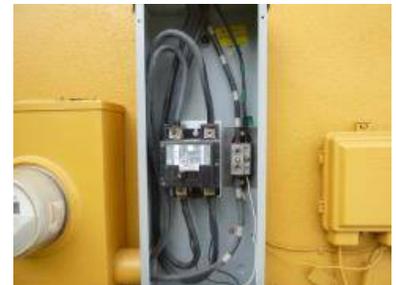
- Location:* Exterior side wall of the home near the garage.
- Cabinet Amperage Rating:* 200 AMPS.
- Main Disconnect:* 200 AMP Breaker.
- Type of Breakers:* The main breaker for this service is a circuit breaker, with circuit breakers in use for the branch circuits.
- Evaluation:* The interior components of the Main Service Panel (load center) were inspected by removing the dead front cover. No interior components in the panel were removed. SERVICEABLE The size of the breakers in relation to the attached cable (conductors) appears to meet standards.

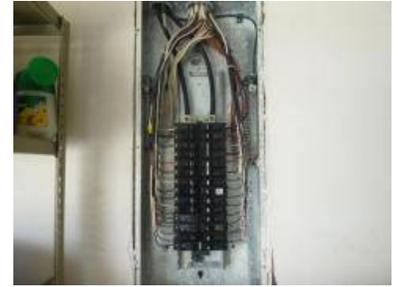
- Primary Sub Panel:* Primary sub panel is located at the garage wall.
- Primary Sub Panel Amperage:* Primary sub panel is rated for 200 AMPS.

Main Breaker: No main breaker in the primary sub panel, common for this type of installation. Main breaker would be at the main panel.

AFCI Breakers: INDETERMINATE There are no AFCI's (ARC fault circuit interrupters/breakers) for 15 & 20 amp circuits in the home. AFCI's are a newer type of breaker that can be beneficial for fire-prevention. AFCI's are intended to trip if there are any loose connections and/or faults within the circuit. Circuit upgrades should be considered. AFCI are not required in laundries, kitchens, bathrooms, garages, and unfinished basements.
